Development and Assessment of Crawl Space Remediation Strategies

Research Highlight

Consultant: Don Figley and Sarah Figley,
Figley Consulting Associates Ltd.

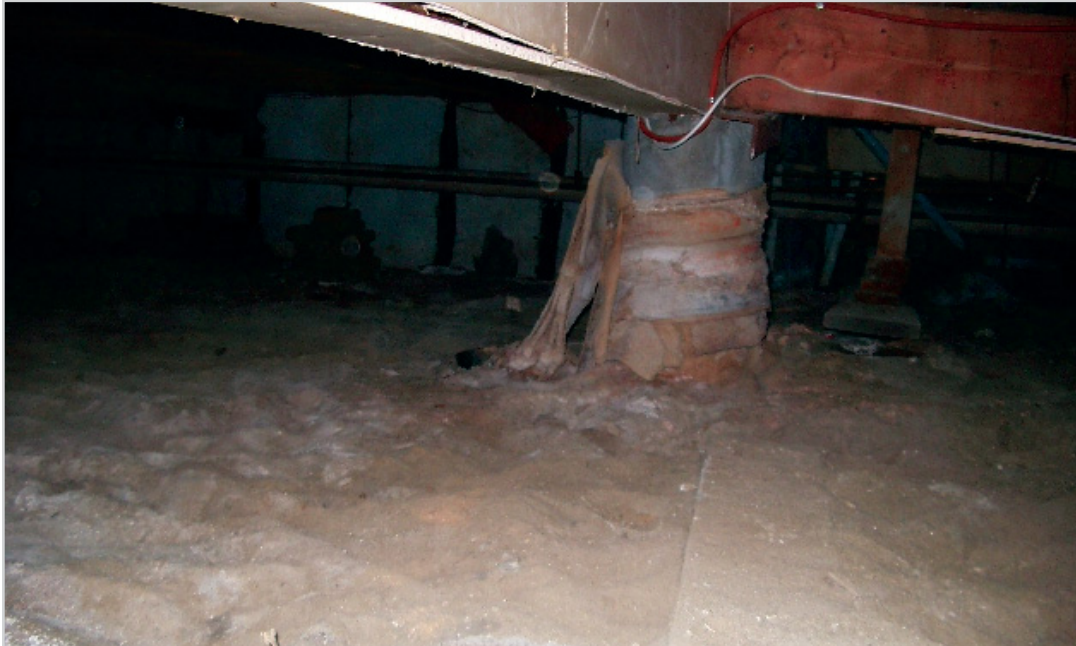
Figure 1 Crawl space before remediation

This crawl space is deteriorated and contaminated. The floor is crudely covered with polyethylene sheets and dirty sand. Many components including insulation, wood, gypsum board and piping show signs of extensive water-moisture damage.
